# **GROUND INVESTIGATION REPORT**

Land off Brick Lane, Mepal

Havebury Housing Partnership

Project no: 49533

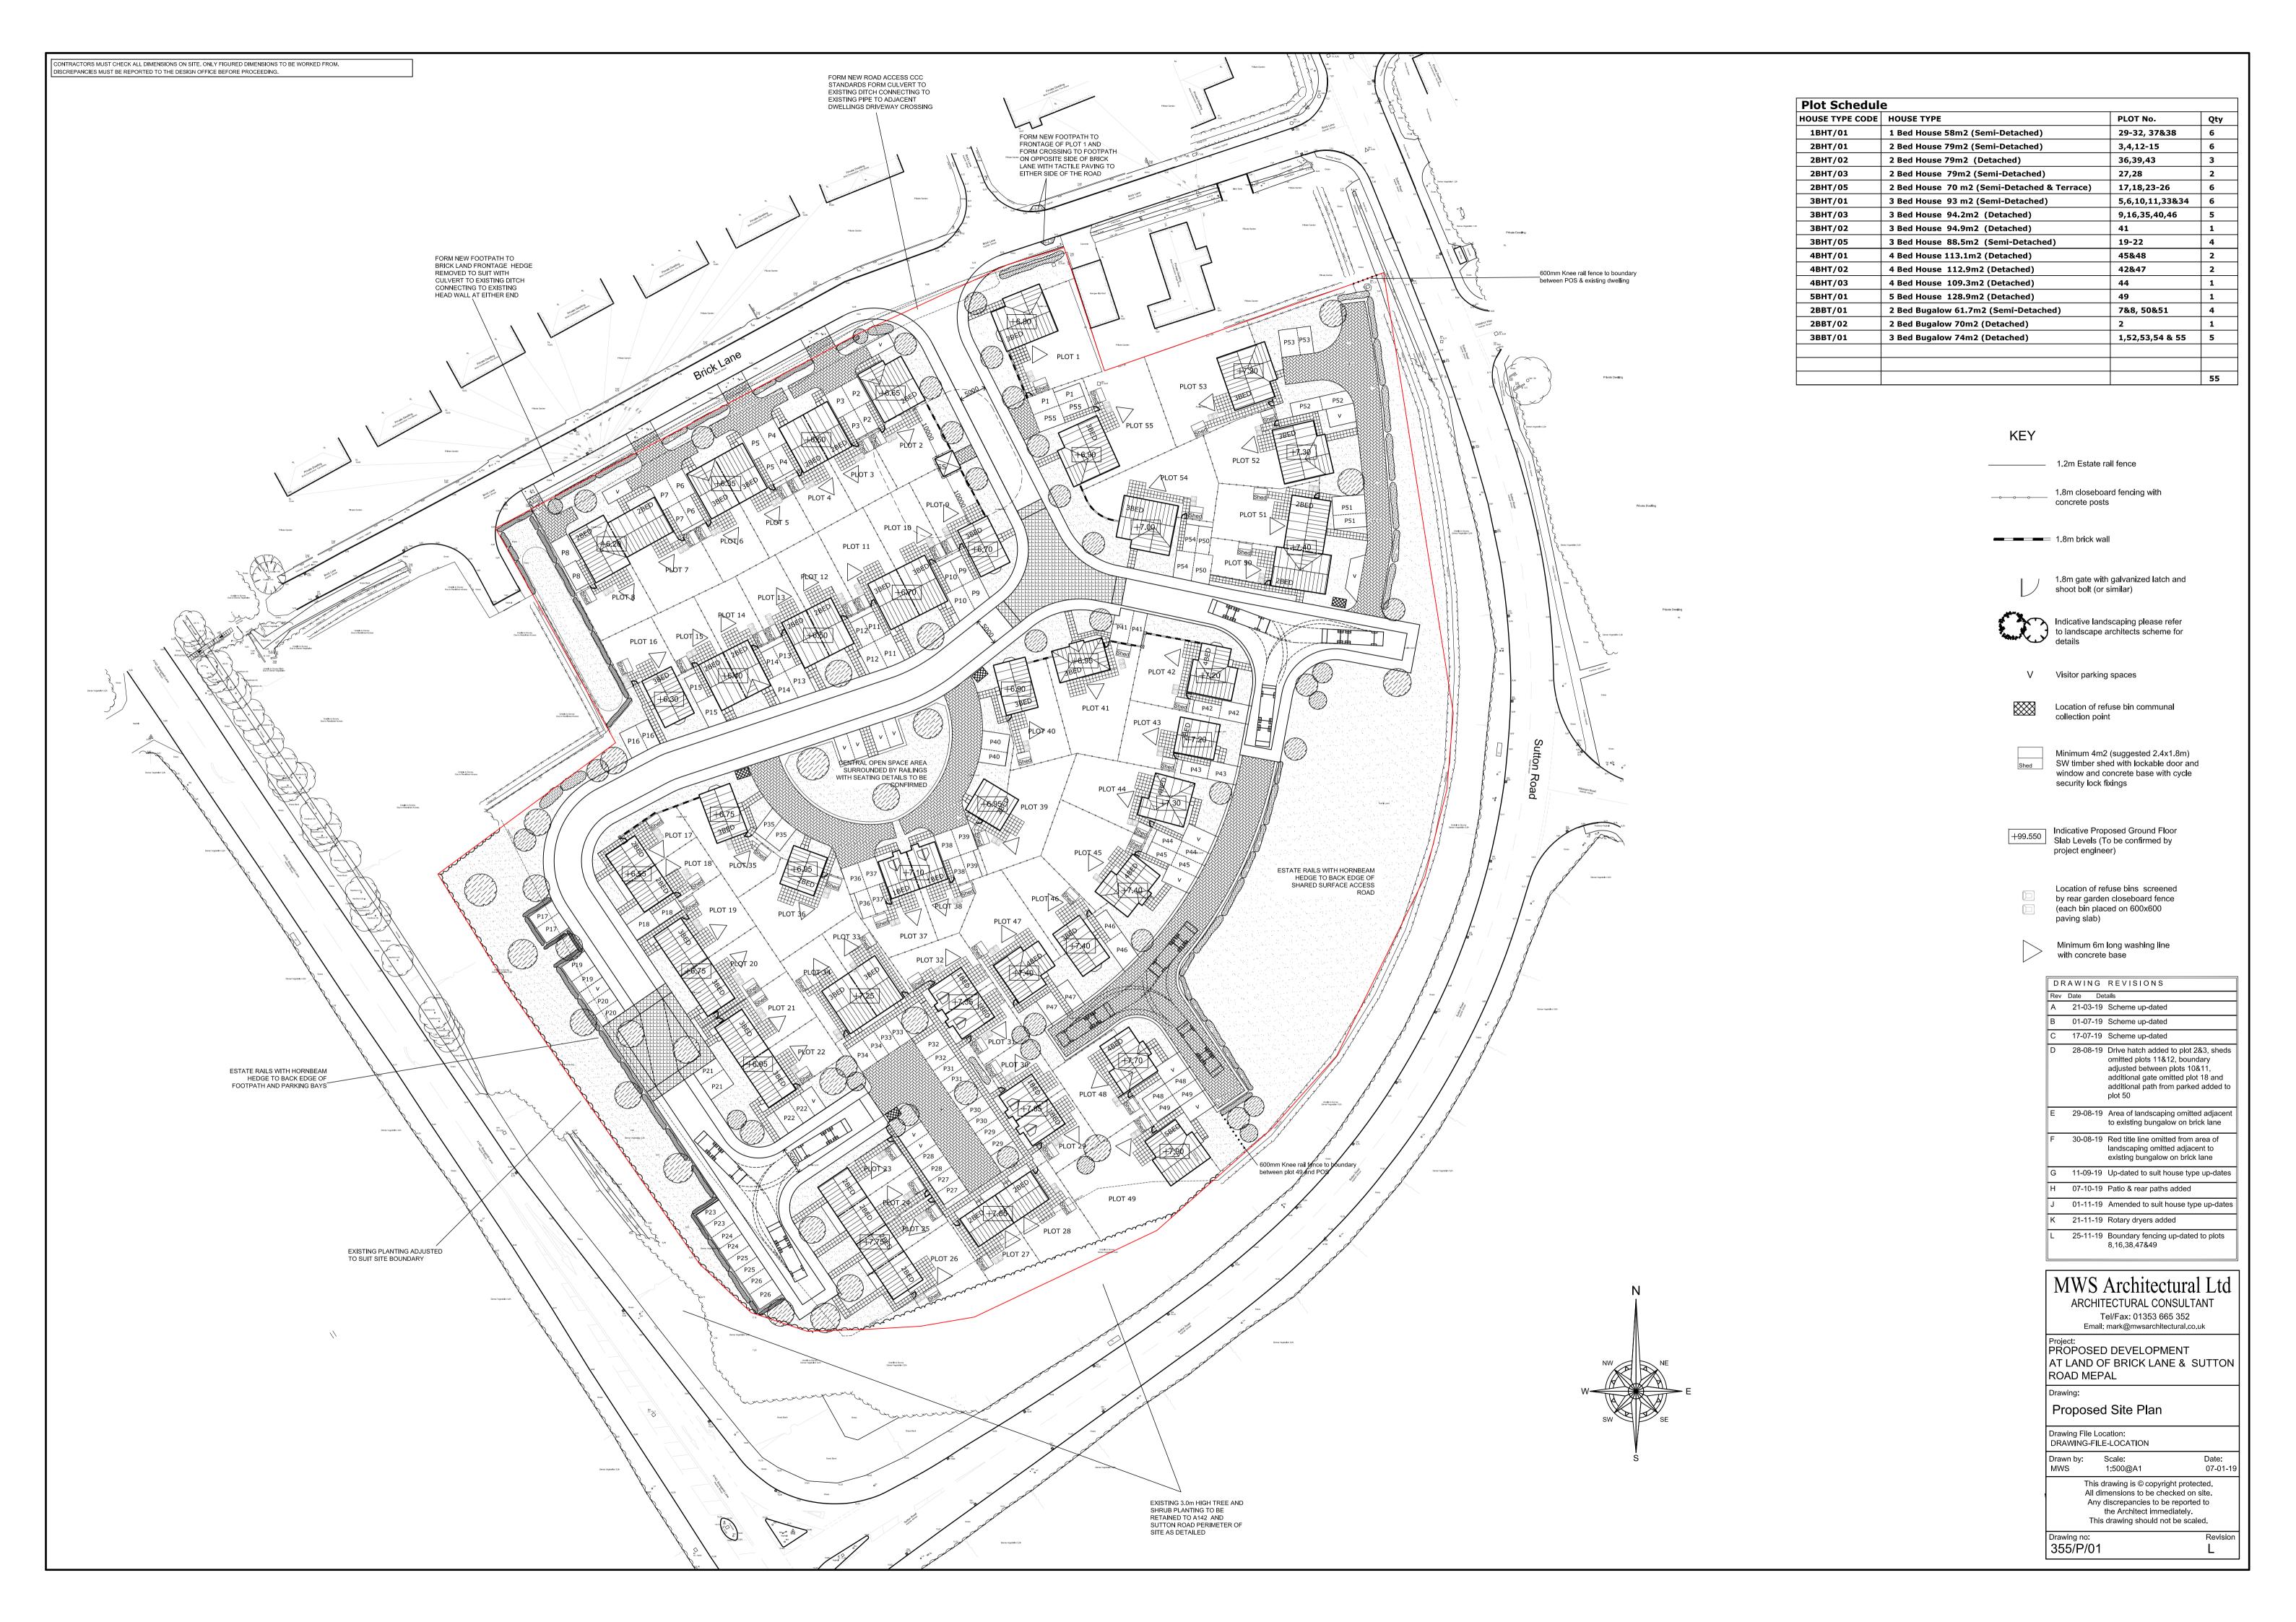
An exploratory hole location plan is presented as Figure 2 in Appendix A.

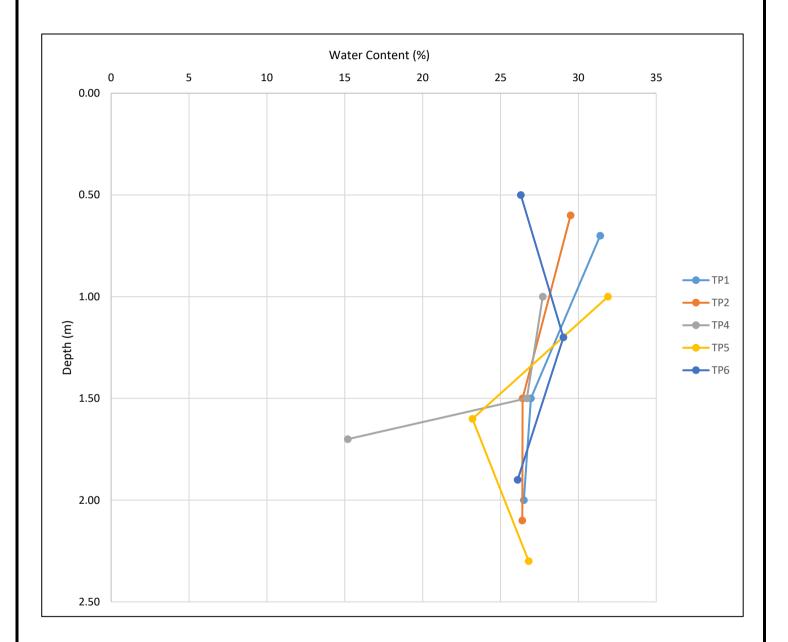
#### WATER CONTENT VS DEPTH BELOW GROUND LEVEL

Method of Preparation: BSEN ISO 17892-1: 2014
Method of Test: BSEN ISO 17892-1: 2014

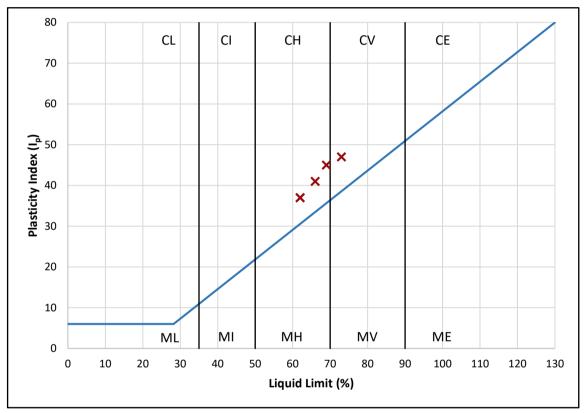
## PLOT OF PLASTICITY INDEX AGAINST LIQUID LIMIT USING CASAGRANDE CLASSIFICATION CHART

Plasticity Chart BS5930: 2015: Figure 8

Interim advice note 73106, Revision 1 (2009) provides recommendations for design CBR values on the basis of soil plasticity. The recorded plasticity index of the K&ACF ranged from 37% to 47%. Therefore, a CBR value of 2.5% is recommended for the preliminary design of thin road pavements. Thin pavement construction is defined as a depth to subgrade of 300mm.
