PHASE ONE DESK STUDY REPORT

Land off Brick Lane, Mepal, Cambridgeshire, CB6 2AH

Havebury Housing Partnership

Project no: 49533

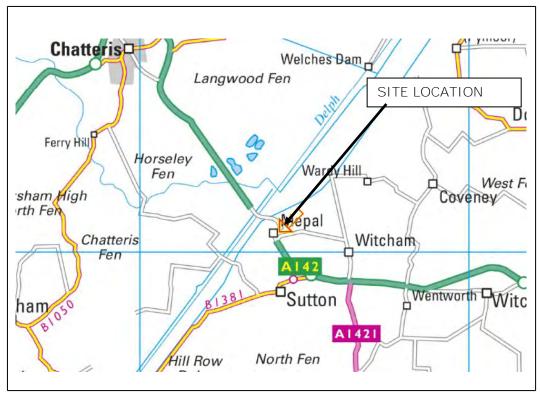
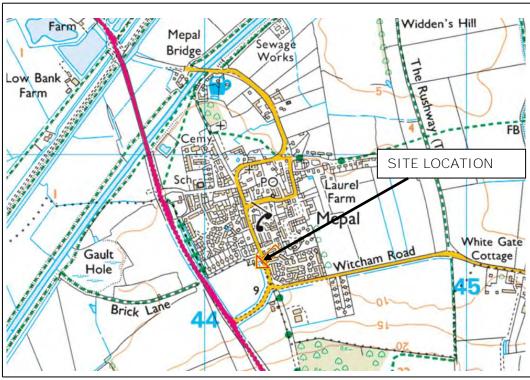
RichardJackson Engineering Consultants	Land off Brick Lane, Mepal, Cambridgeshire, CB6 2AH	FIGURE 1
consulting civil & structural engineers 847 The Crescent, Colchester, CO4 9YQ	SITE LOCATION PLAN	SCALE: N.T.S.
Tel: 01206 228 800		JOB NO: 49533

The site was located to the south of Brick Lane, Mepal, Cambridgeshire, CB6 2AH. The approximate Ordnance Survey grid reference for the centre of the site was TL 441 805. A site location plan is presented as Figure 1 in Appendix A. Photographs taken at the time of site walkover are presented in Appendix B.

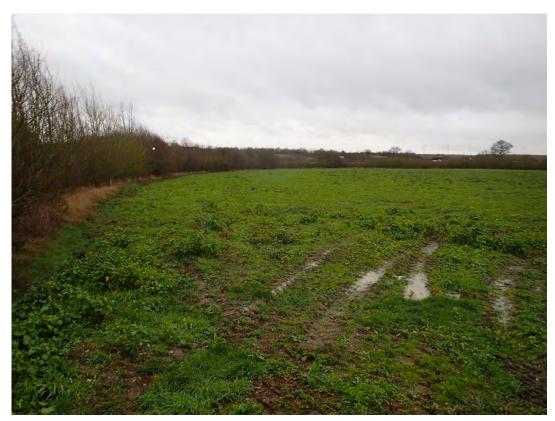
Photo 1 View of site facing south (Sutton Road is beyond the hedge on the left).

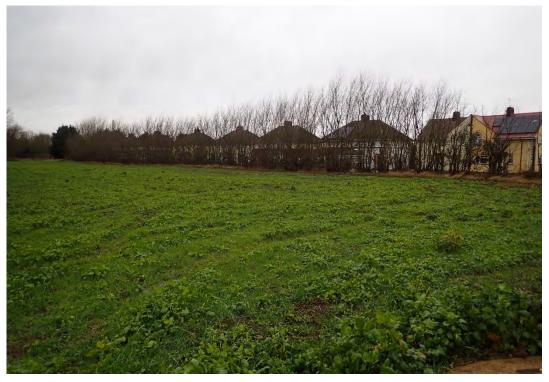
Photo 2 View of site facing north, showing Brick Lane and residential properties beyond.

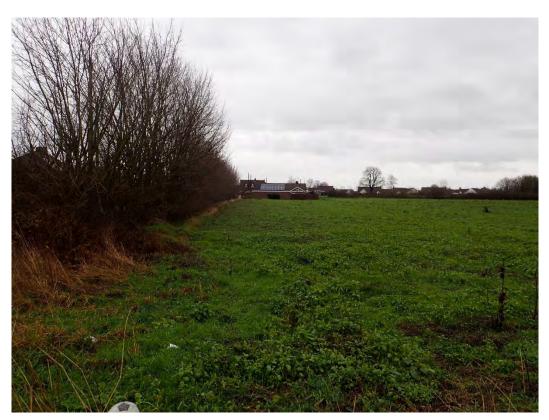
The eastern/south-eastern boundaries of the site were formed by a hedgerow with occasional trees, with a ditch and Sutton Road beyond. To the east of Sutton Road were residential properties and to the south was an agricultural field.

Photo 3 View of site along eastern boundary.

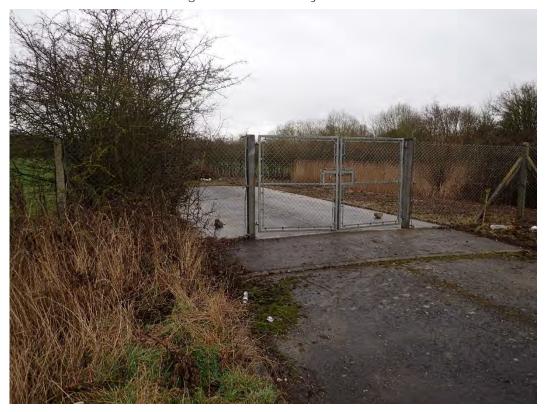
In the northwest corner, the site boundary comprised a wire mesh fence surrounding a compound with a pond. The remainder of the northern boundary comprised a row of trees with a ditch, Brick Lane and residential properties beyond. The ditch was observed to contain running water, flowing to the west.

Photo 4 Compound and pond immediately off-site to the northwest.

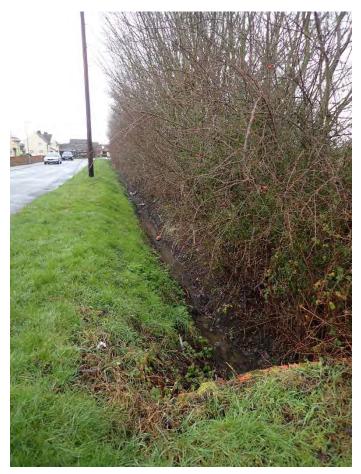
Photo 5 Ditch and trees running between site boundary and Brick Lane.
